Determination of radon transmittance

The client delivered their product which was named Zemseal PA to RISE Research Institute of Sweden on 2020-04-23. There were no signs of visible damage to the material on arrival. The material was tested without joints. See Appendix 2 for a picture of the material.

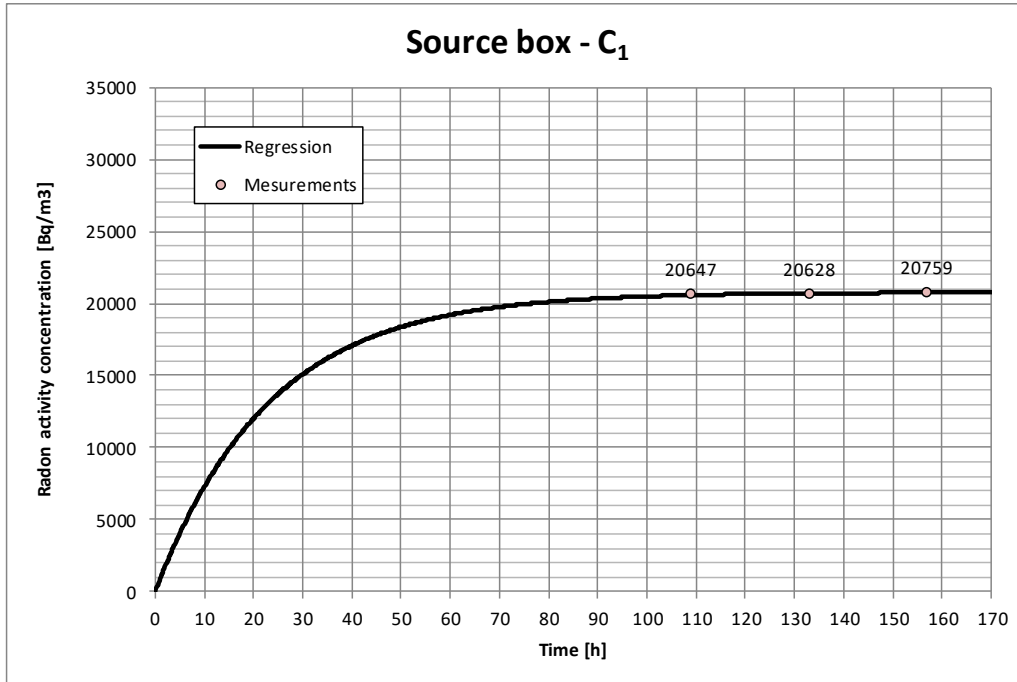
Figure 1 Radon concentration in the primary box: measured daily average values and the regression curve.

box. This difference causes a flow of radon by diffusion through the test material. Only radon gas (Rn) passes through, and not its decay products (RnD). Radon transmittance is measured by measuring the change in radon concentration on both sides of the test material. Figures 1 and 2 show how the radon concentrations build up in the two boxes.

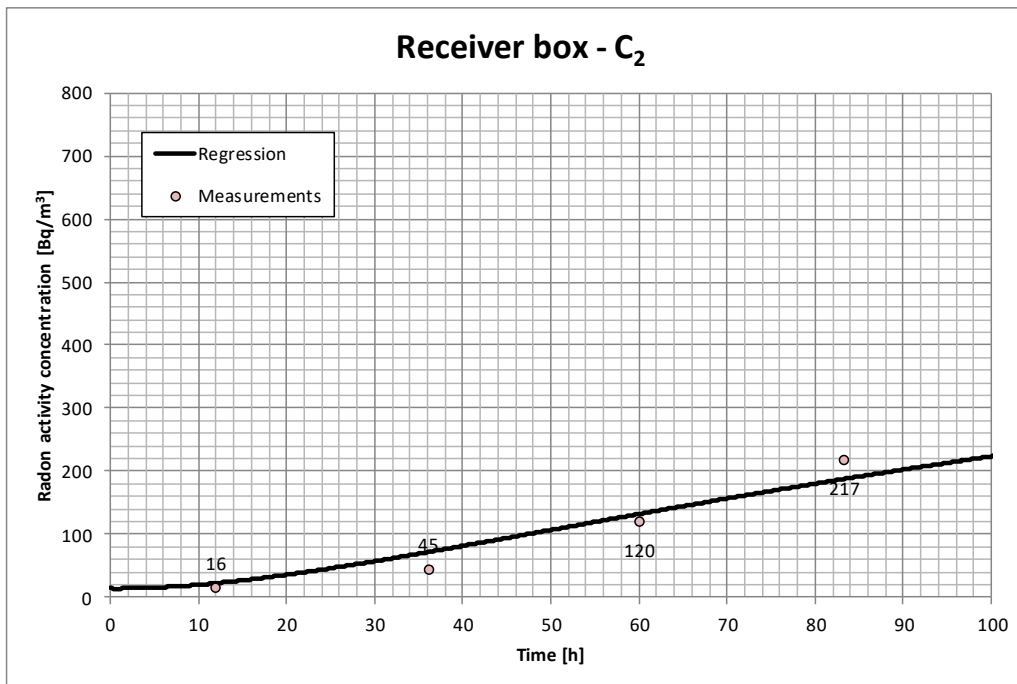
Figure 2 Radon concentration in the secondary box: measured daily average values and the regression curve.

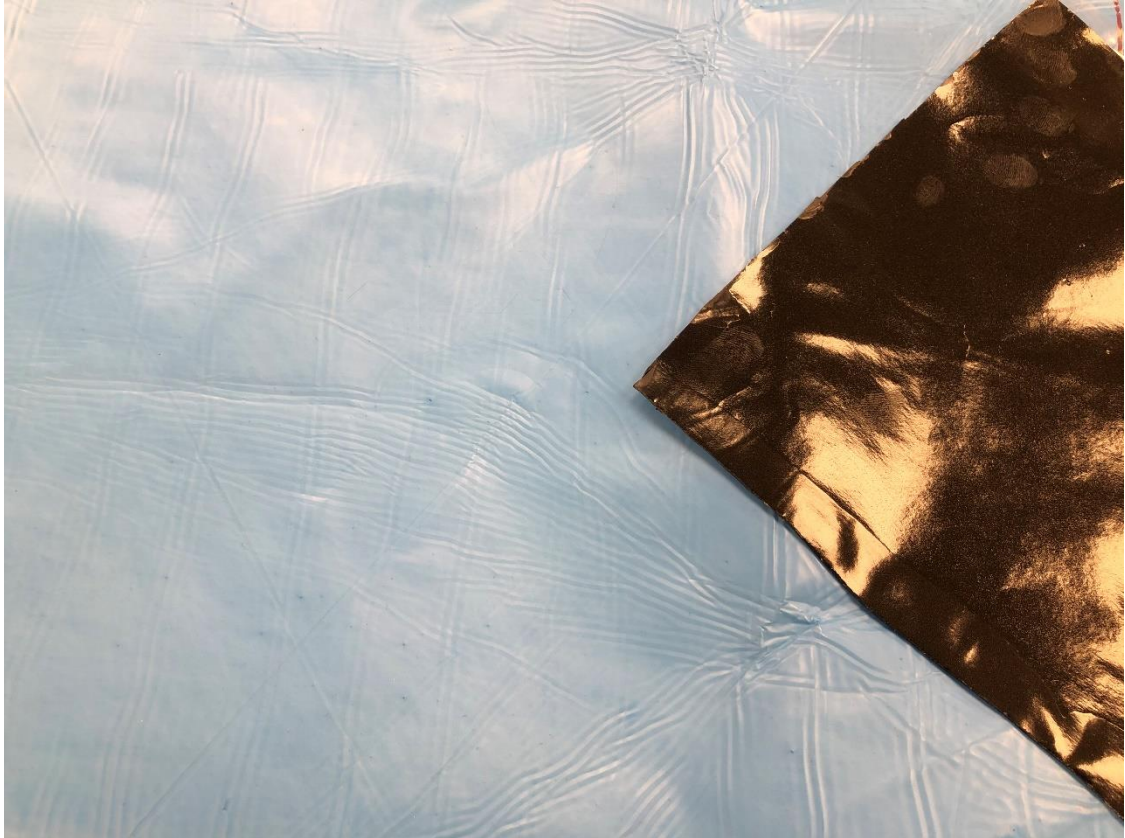
Zemseal PA

Photographs of the tested material
